**TAUNTON RIVER BASIN  
NORTON, MASSACHUSETTS**

**CHARTLEY POND DAM  
MA 00814**

**PHASE I INSPECTION REPORT  
NATIONAL DAM INSPECTION PROGRAM**

**APRIL 1979**

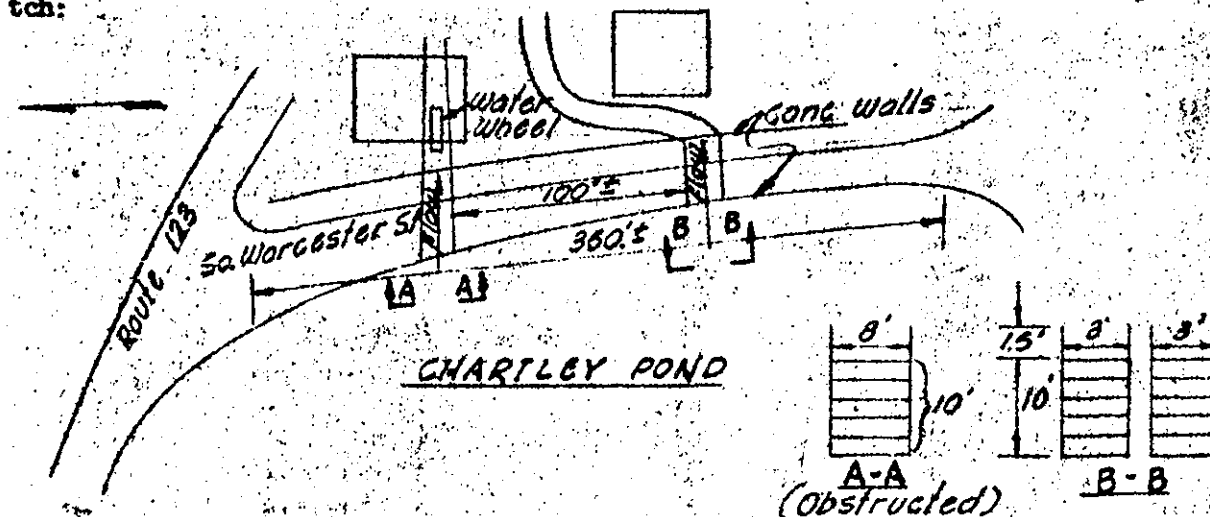
Remarks and Recommendations: Reconstruction proposed in House #3270  
Discharge provisions inadequate.  
Downstream channel inadequate  
Owner has however, been able to maintain pond elevation  
during all floods of 1955 (record year)

Recommend new spillway,  
Channel widening downstream.

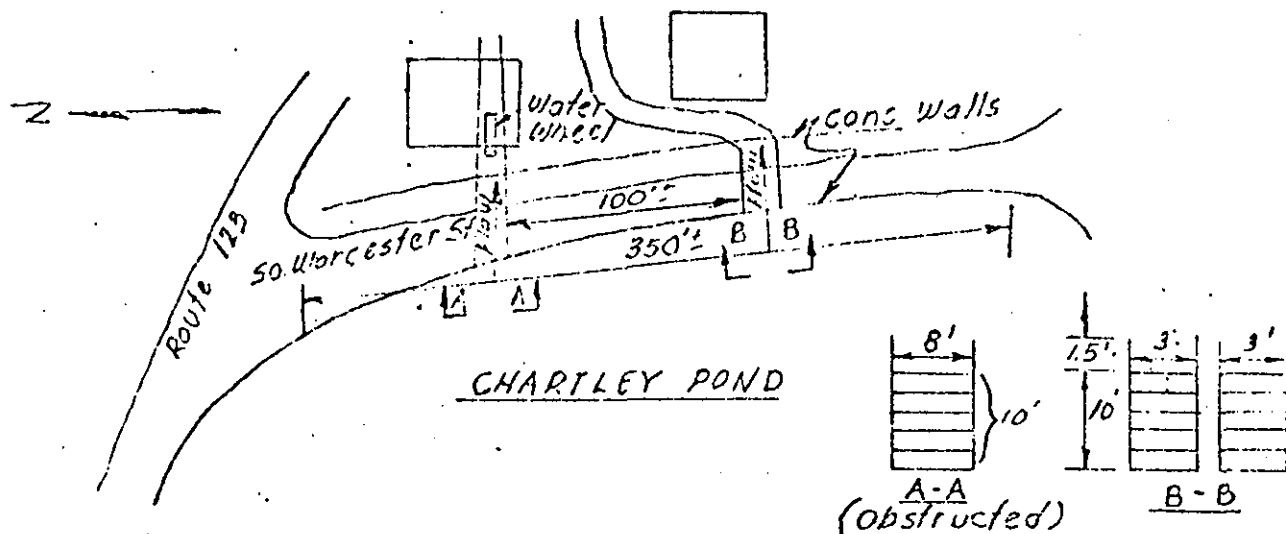
Remarks and Recommendations: Reconstruction proposed in House #3270  
Discharge provisions inadequate. Downstream channel inadequate. Owner  
has, however, been able to maintain pond elevation during all floods of  
1955 (record year) Recommend new spillway, Channel widening downstream.

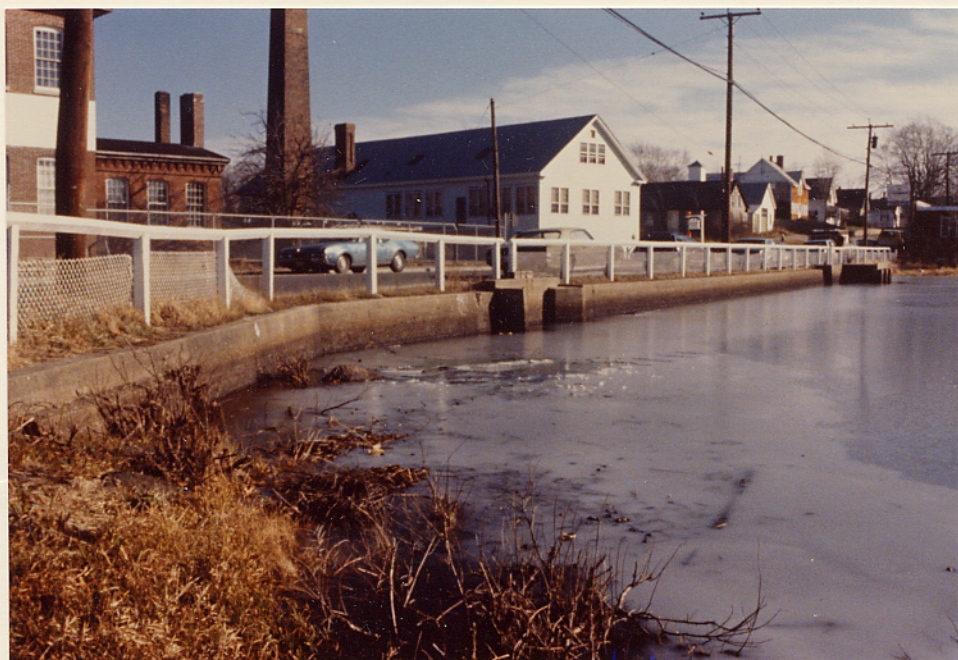
The upstream face of the dam is comprised of a continuous concrete wall (no joints) in fair condition. Minor cracking was noted in regular intervals along the wall. The cracks ranged in size from hairline to about 1/4 inch. The concrete face was pitted and stained. Minor erosion, in the form of small holes, between the wall at the outlet and the embankment was evident.

**NO. 1 VIEW OF UPSTREAM FACE**

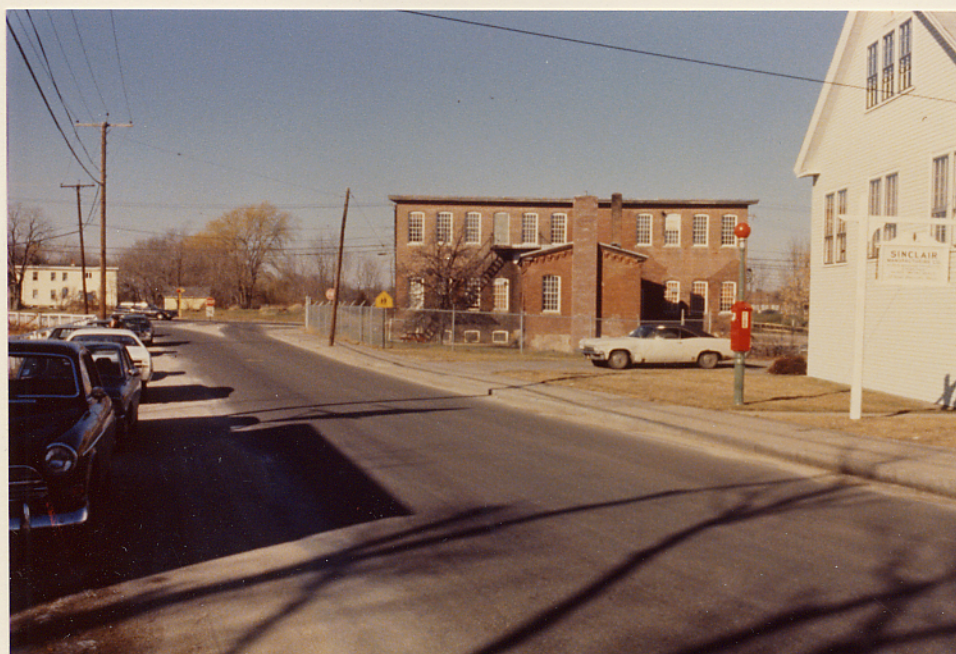
**NO. 2 VIEW OF ROADWAY ACROSS CREST OF DAM**

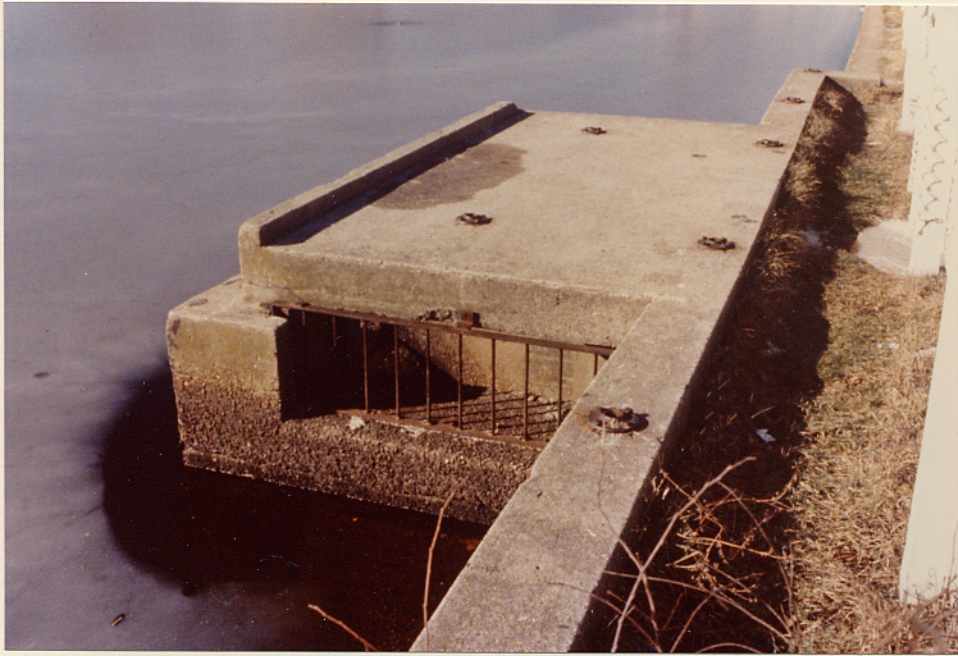
Discharge through the outlet of the dam is controlled by wooden stop logs. The sides of the outlet structure have two fixed weirs. Removing all of the stop logs will drain the pond. The concrete structure was in good condition. Just to the east of the structure was a steel pin which the Owner stated marked the legal "high water limit" (El 104.5). Staining along the structure and upstream wall indicated the pond level rarely rose above this elevation for long periods of time.

**NO. 3 VIEW OF OUTLET STRUCTURE**

- (1) Until such time as when the hydraulic analysis and evaluation has been completed and recommendations incorporated, all the stop logs should be removed and the pond drained to minimizing potential overtopping.
- (2) Fill holes near the downstream wall and at the outlet.
- (3) Investigate the condition of the blocked outlet.
- (4) Implement a systematic program of maintenance inspections. As a minimum the inspection program should consist of a bi-monthly (every two months) inspection of the dam and appurtenances, supplemented by additional inspections during and after severe storms. All repairs and maintenance should be undertaken in accordance with all applicable State regulations.
- (5) Technical inspection of this dam should be continued on a bi-ennial (every two years) basis.

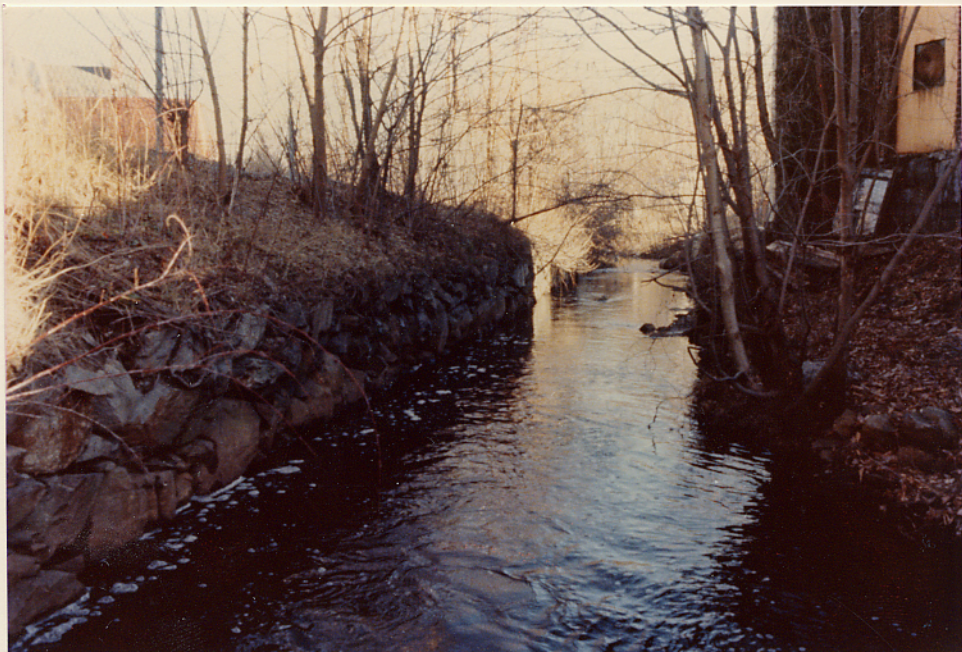
**NO. 4 VIEW OF DOWNSTREAM CHANNEL**

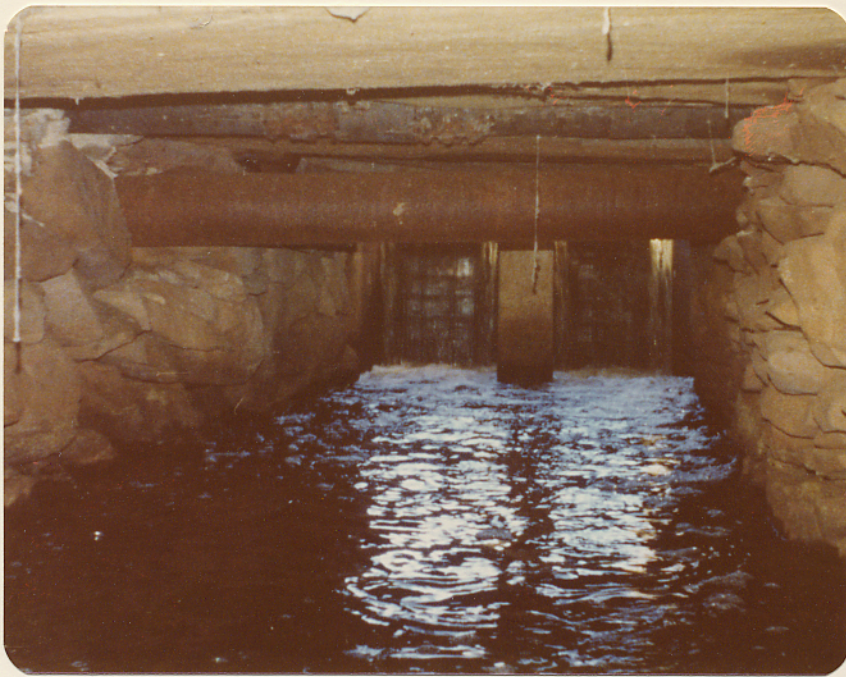
A depression was observed at the grassed area near the edge of the outlet discharge channel. It appears that soil may have infiltrated through the void in the stone masonry of the discharge conduit.

**NO. 5 VIEW OF DISCHARGE CONDUIT THROUGH DAM**

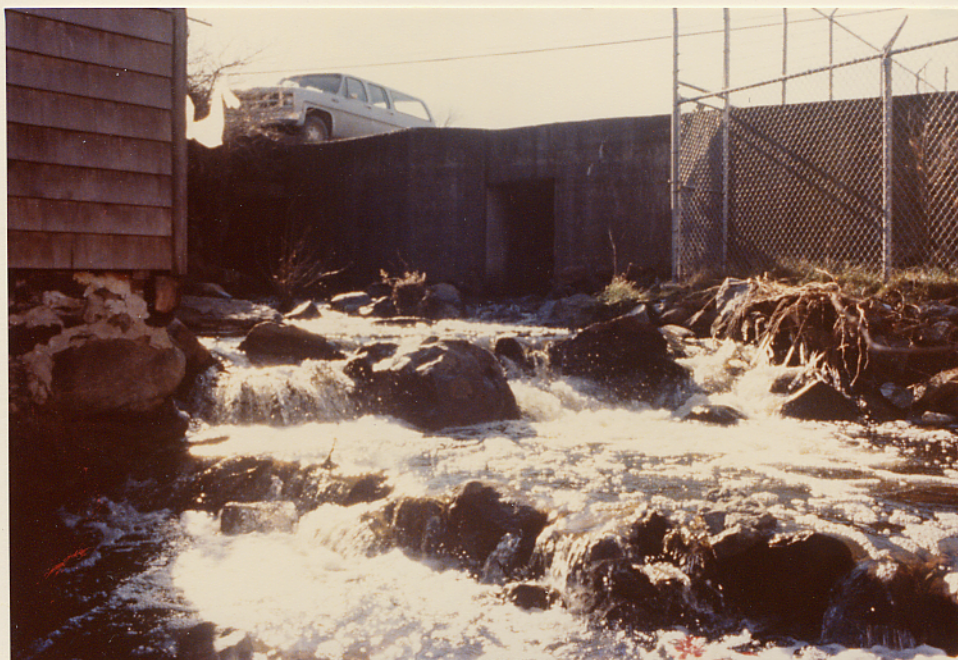
**NO. 6 VIEW OF OUTLET AND DOWNSTREAM DISCHARGE CHANNEL**
